Accurate Home & Termite Inspections, Inc.

Home Inspection Report Prepared For: John Smith Property Address: 123 Accurate Ln Fredericksburg , VA 22401 Inspected on Tue, Dec 8 2020 at 8:06 AM

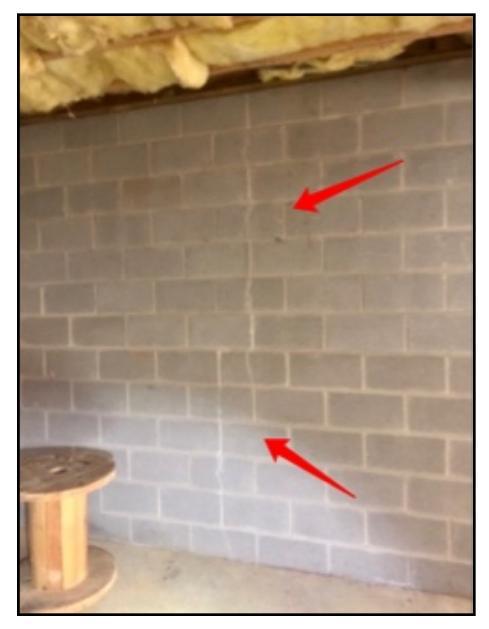
Figure 1-1

Typical hairline settlement cracks are present in the basement concrete block foundation wall. Monitor and make repairs if needed.

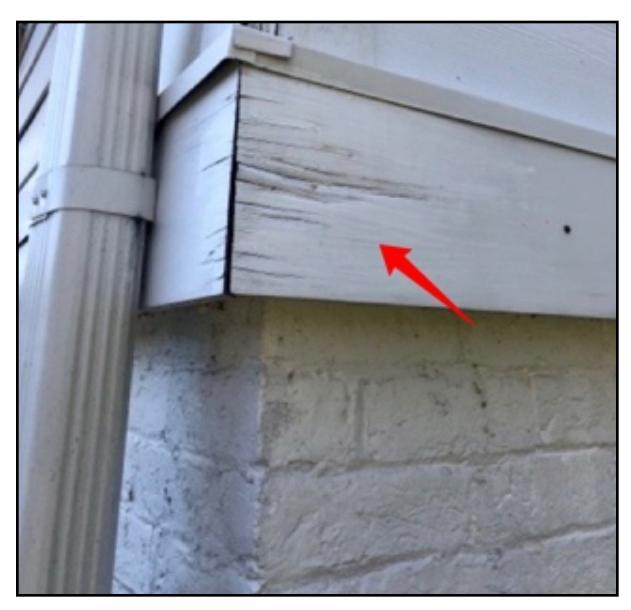
Figure 2-1

Multiple locations of exterior wood rot is present. See contractor for repairs.

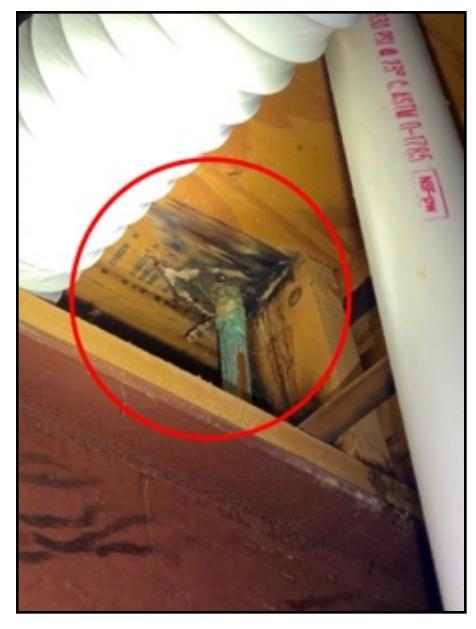
Figure 3-1

Current slow leak with wet/soft wood present where the main hot water supply goes through the subfloor above the hot water heater in the basement. See plumber for repair.

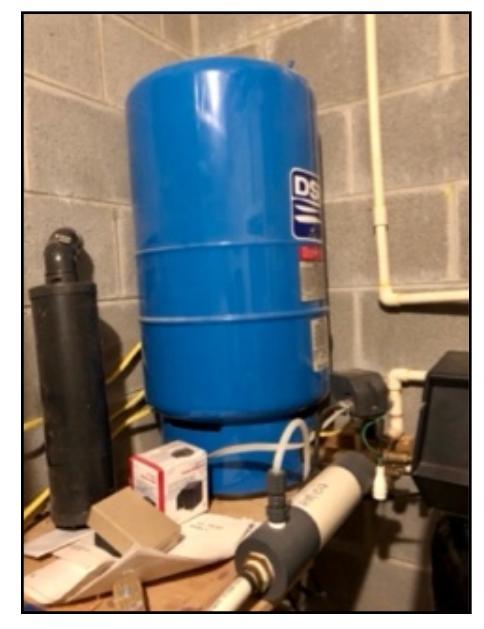
Figure 4-1

Well pressure tank, main water valve, & exterior hose bib shut off valve located in basement utility room.

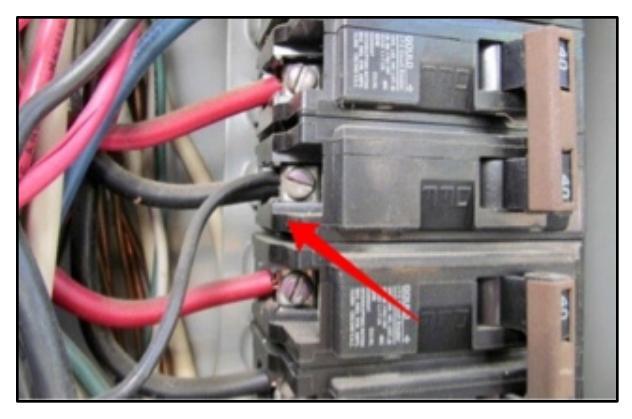
Figure 5-1

Double tapped electrical breaker is present in the 200 amp electrical panel located in the basement utility room. See licensed electrician for repairs.

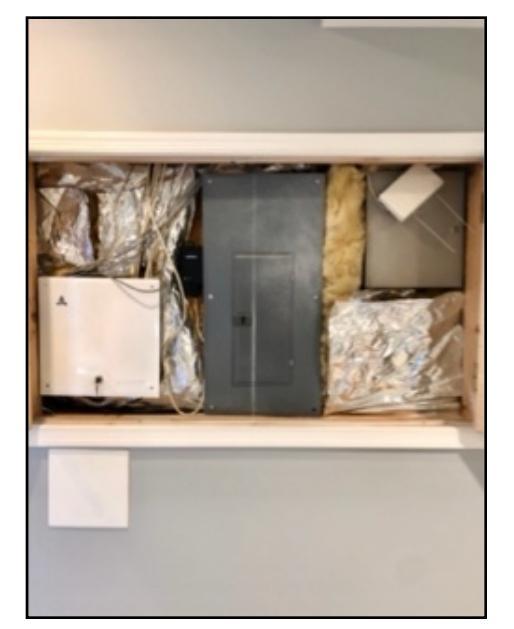
Main 200 amp electrical panel located in basement.

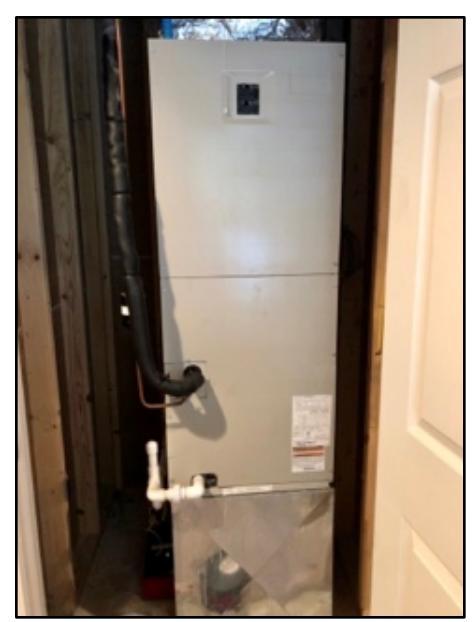
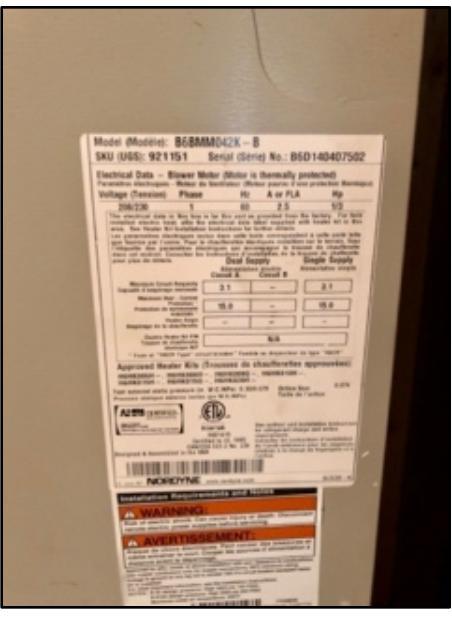
2014+/- Nordyne air handler located in basement utility closet.

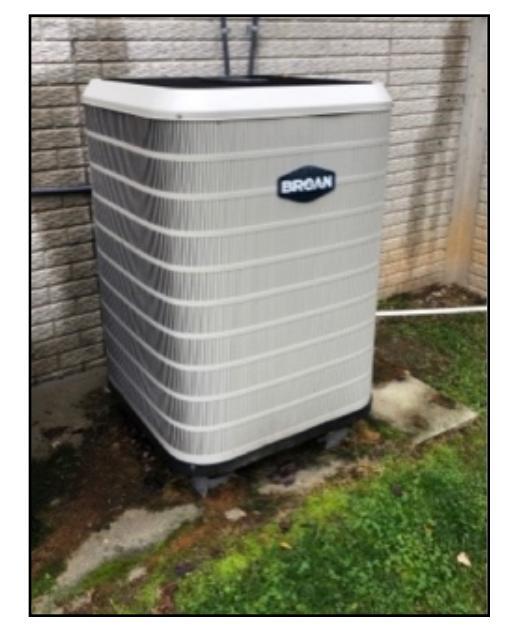
Figure 8-1

Comment 8: 2014+/- Broan 3 ton unit.

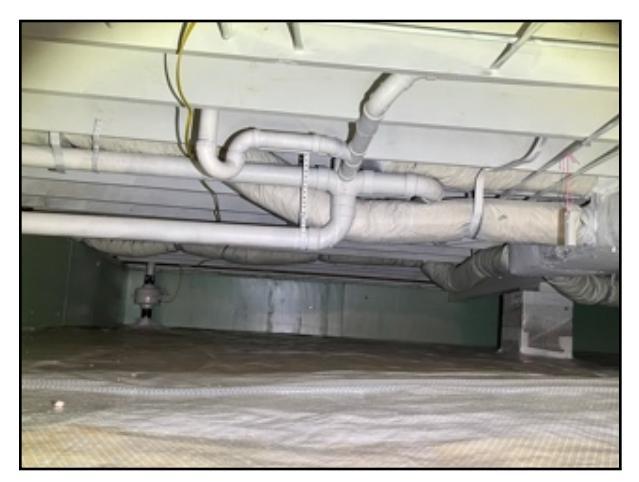
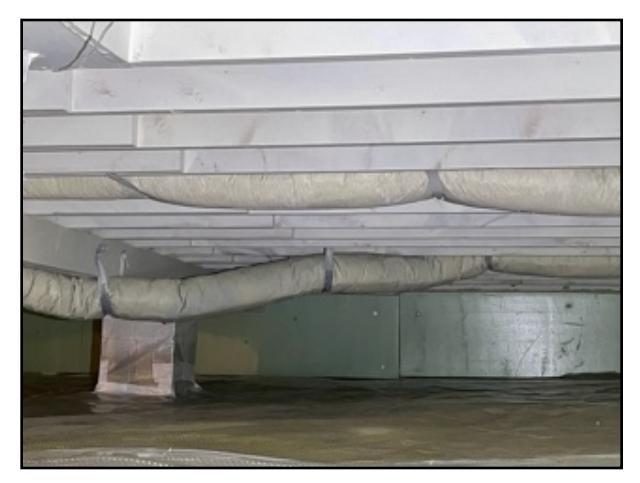
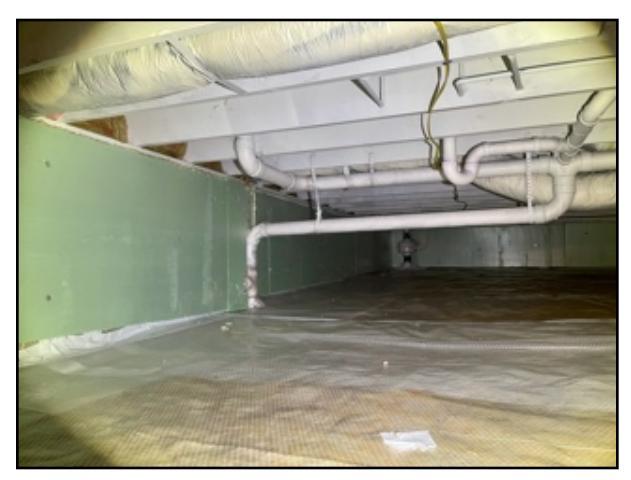
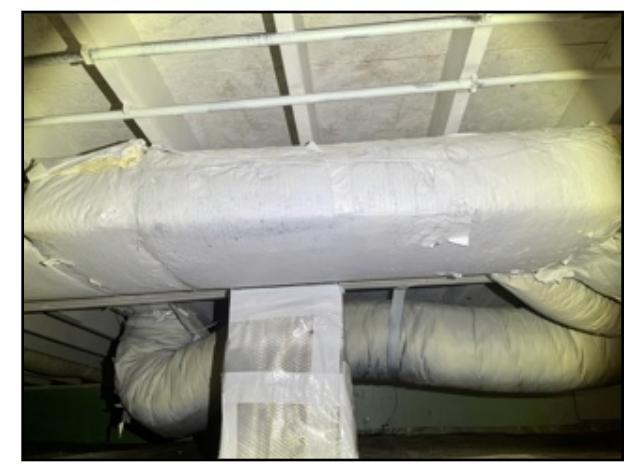
Comment 9: Interior crawlspace condition.

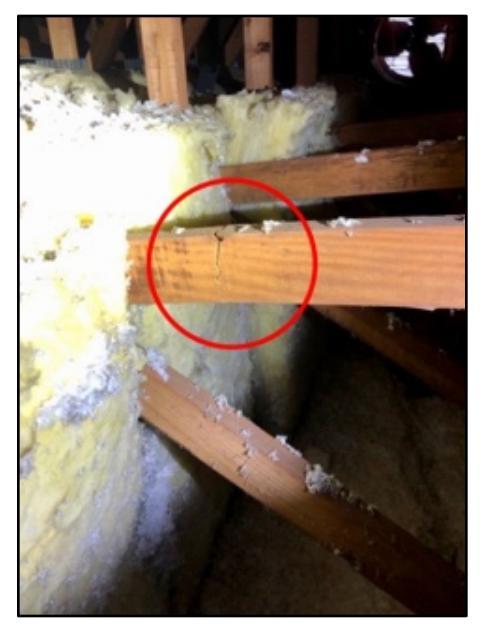
A broken attic truss is present in the attic. See contractor to properly sister brace truss.

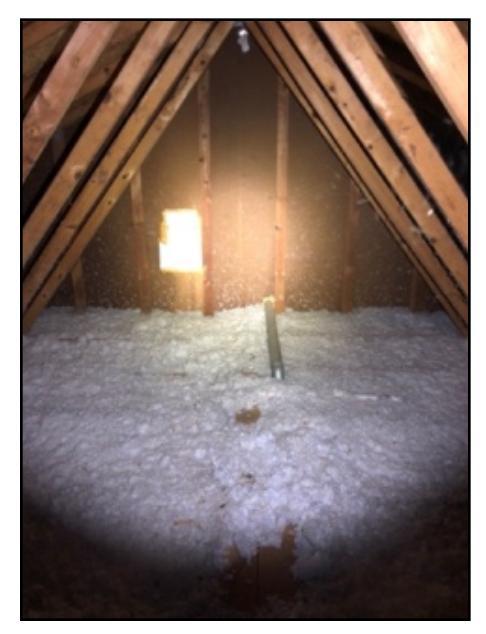
Figure 11-1

Comment 11: Attic structure and insulation.

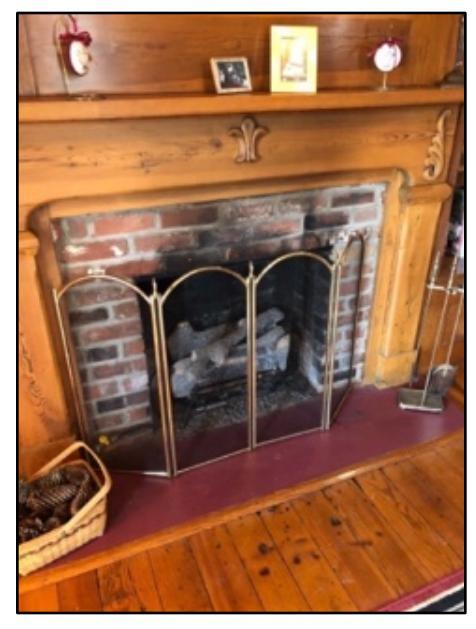
Fireplace is in working order. See fireplace specialist for cleaning, periodic inspections, & cleaning.

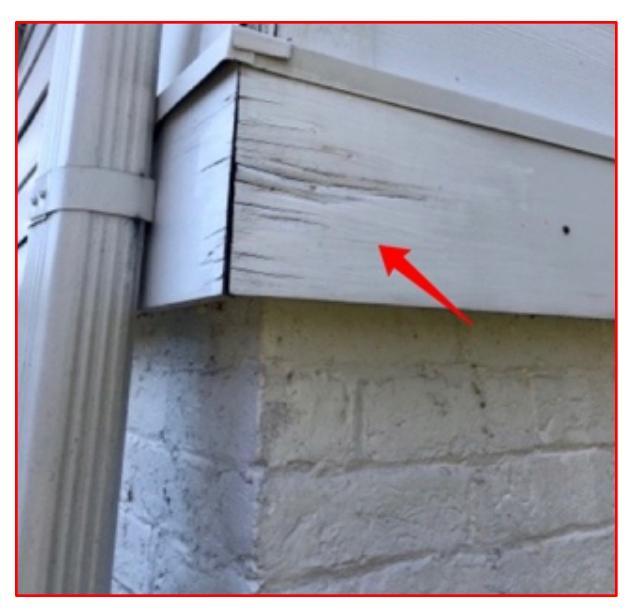
Figure 2-1

1) Multiple locations of exterior wood rot is present. See contractor for repairs.

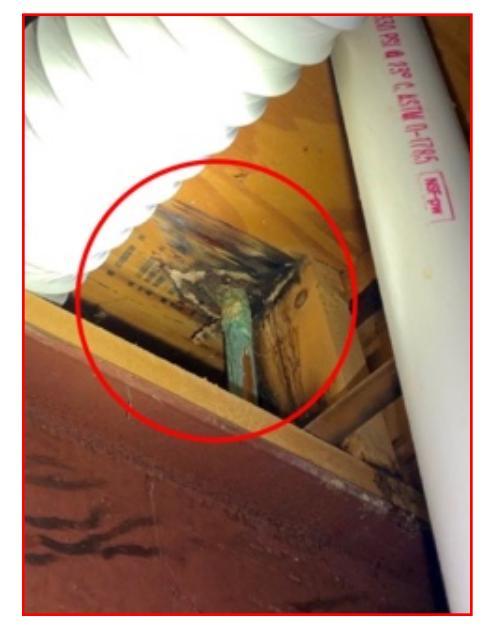
2) Current slow leak with wet/soft wood present where the main hot water supply goes through the subfloor above the hot water heater in the basement. See plumber for repair.

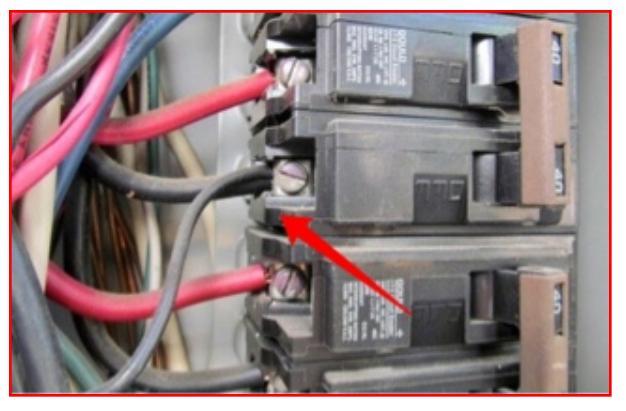
3) Double tapped electrical breaker is present in the 200 amp electrical panel located in the basement utility room. See licensed electrician for repairs.

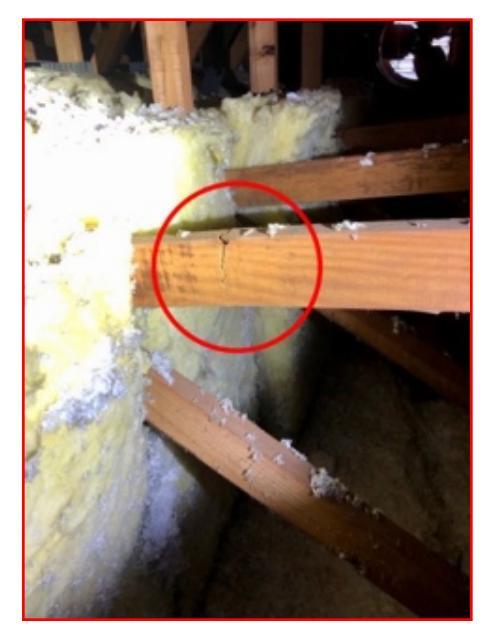
Figure 10-1

4) A broken attic truss is present in the attic. See contractor to properly sister brace truss.
